**Informing the Conservation and Long-term
Management of Barnsley Main Colliery**

CONSERVATION MANAGEMENT PLAN

November 2015

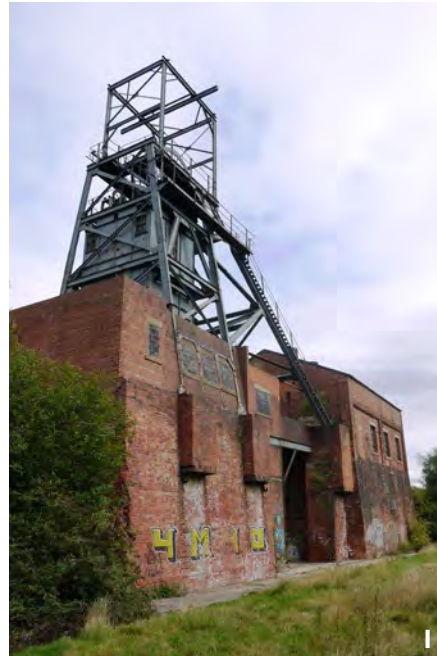
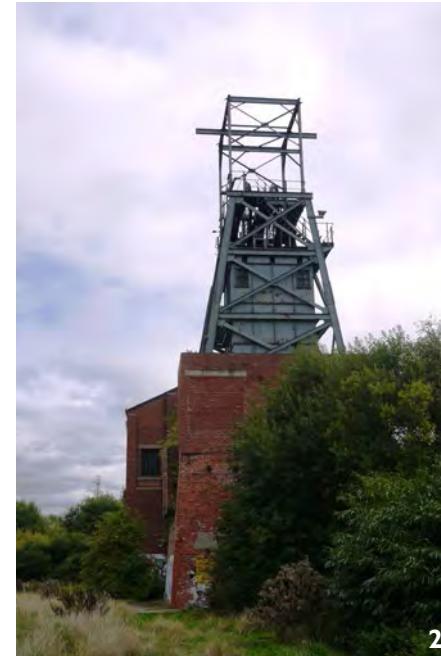
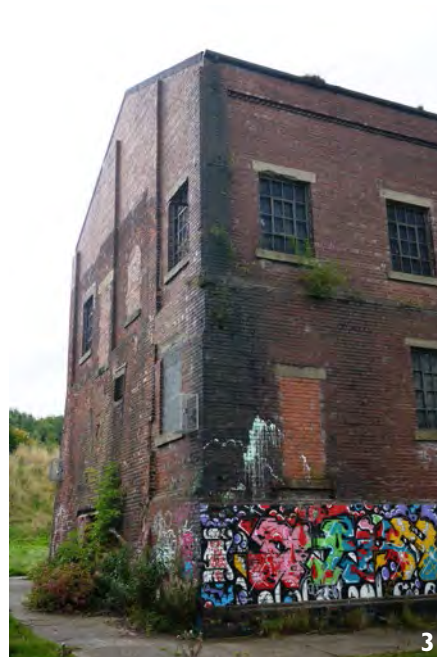
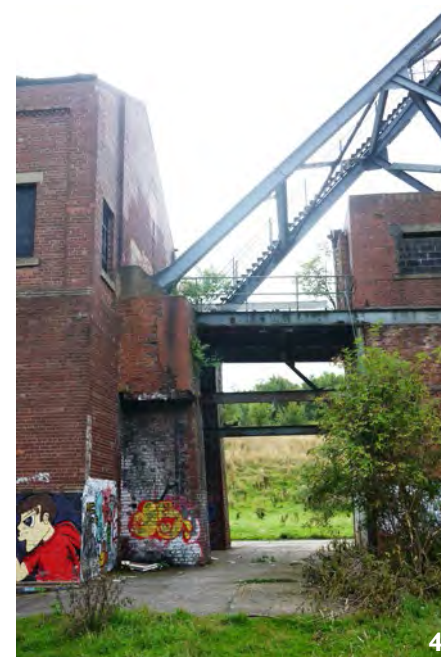
- 1 South-west elevation of the site
- 2 North-west elevation
- 3 South-east elevation
- 4 Winding house and headstocks building, looking south

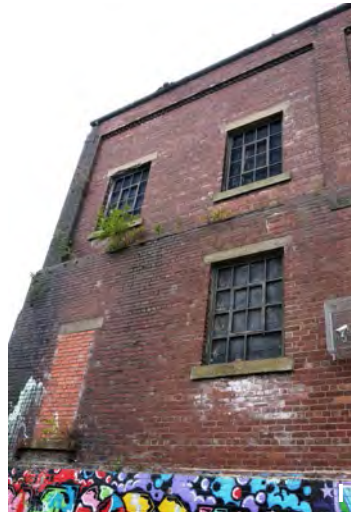
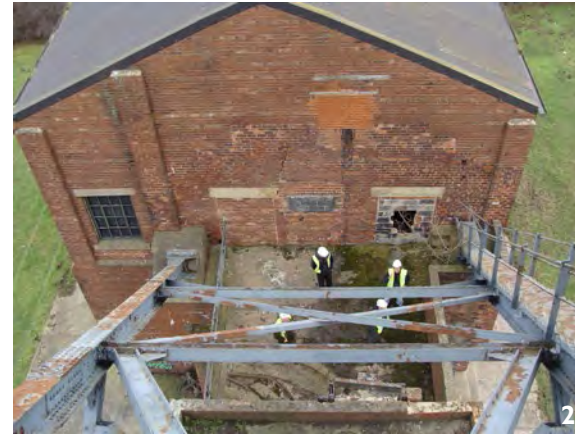
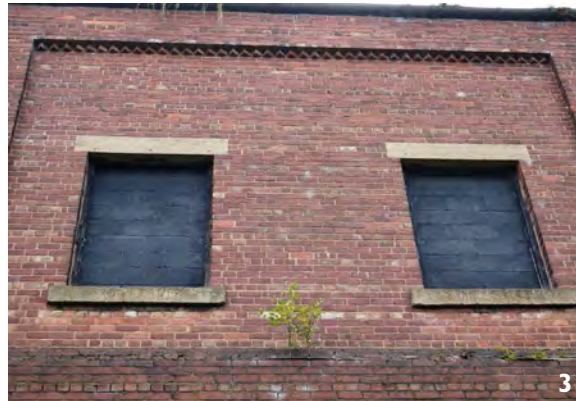
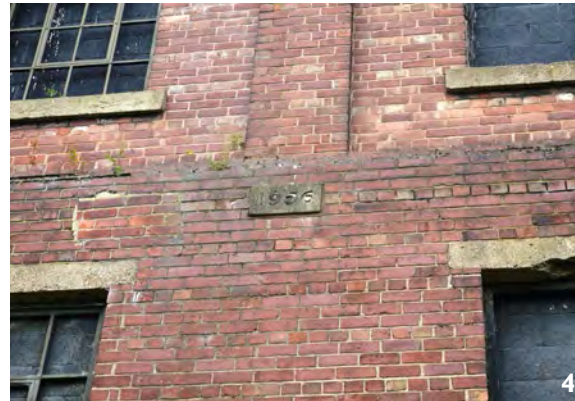
Internally the winding engine house retains the electrically powered drum winder, hydraulics for the breaking system, control cabin, and an overhead travelling gantry crane. The internal spaces cannot be safely accessed due to debris and large unprotected openings in the floors.

On the ground floor the entrances to the site have been blocked with steel doors or block-work. There is low level graffiti and CCTV has been installed in an attempt to curb anti-social behaviour.

- 1 North-east elevation of the winding house
- 2 View of the winding house north-west gable (© BMBC)
- 3 Brickwork rebuilt at first floor level in 1956
- 4 Date stone of 1956
- 5 Early details on the south-east elevation
- 6 Controls for the winding wheel

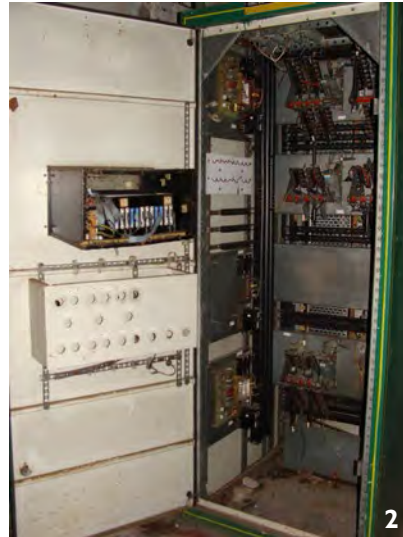
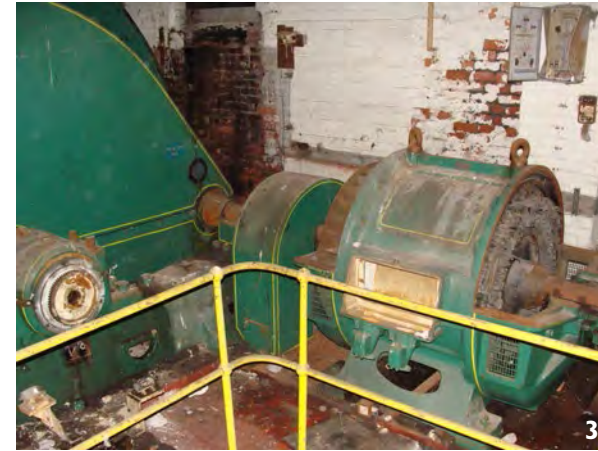
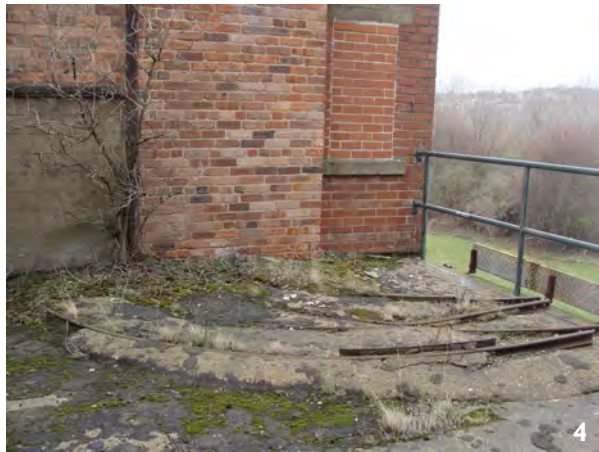
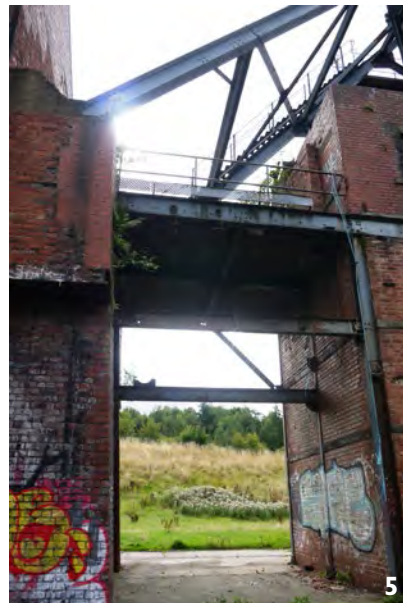
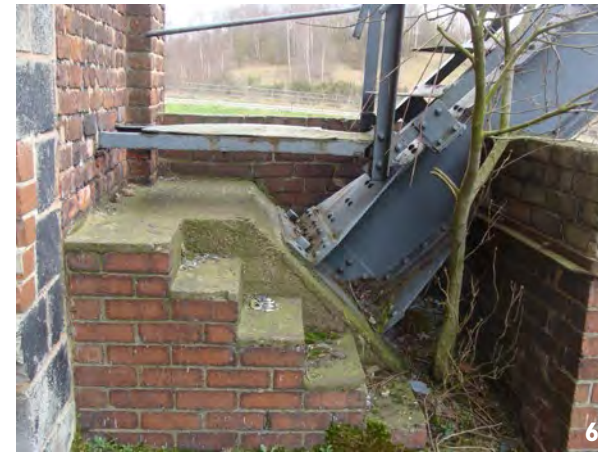
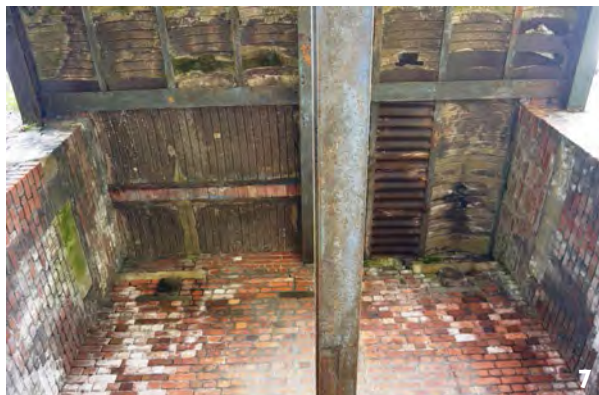
- 1 Winding wheel inside the winding engine house (© BMBC)
- 2 Electrical distribution and fuse cupboard (© BMBC)
- 3 Electric motor associated with the winding wheel (© BMBC)
- 4 Trackways at first floor level (© BMBC)
- 5 First floor gantry between the two buildings
- 6 Connection between the steel framework and the building (© BMBC)
- 7 View of the first floor gantry from below

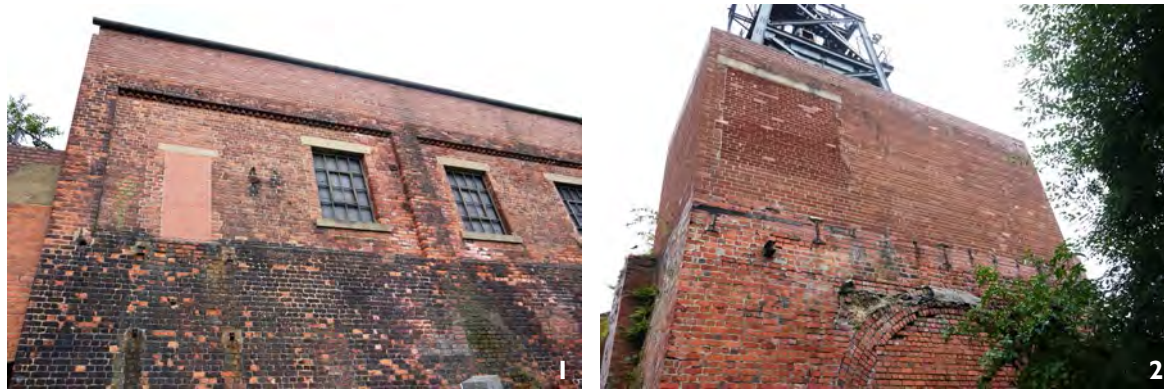
The headstock itself has a steel enclosure for a pair of double deck cages, two pit winding wheels and a third, smaller, emergency winding wheel. Features also include maintenance gantries and walkways.

- 1 South-west elevation showing the early 20th century brickwork and later brickwork associated with raising the roofline
- 2 North-west elevation showing the mid-20th century brickwork above the earlier arched entrance for tubs and the railway tracks.
- 3 Winding wheels of the headstock (© BMBC)
- 4 Unprotected drop from the first floor (© BMBC)
- 5 Headstock lift structure (© BMBC)
- 6 View of the brick arched opening within the headstock building (© BMBC)
- 7 View upwards towards the headstocks within the lift shaft (© BMBC)

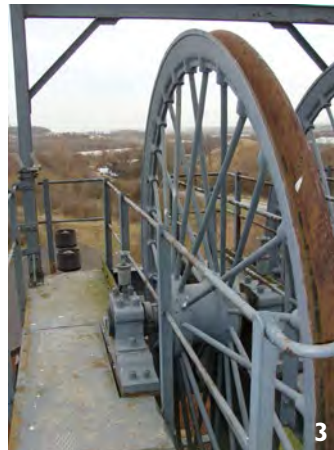
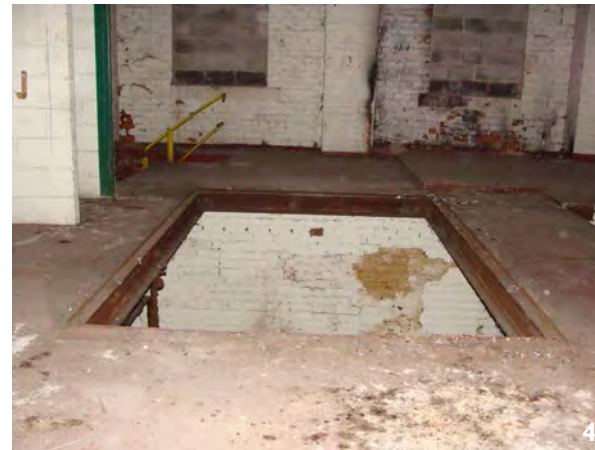
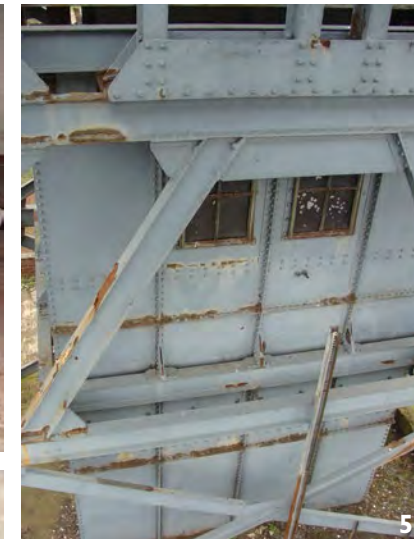
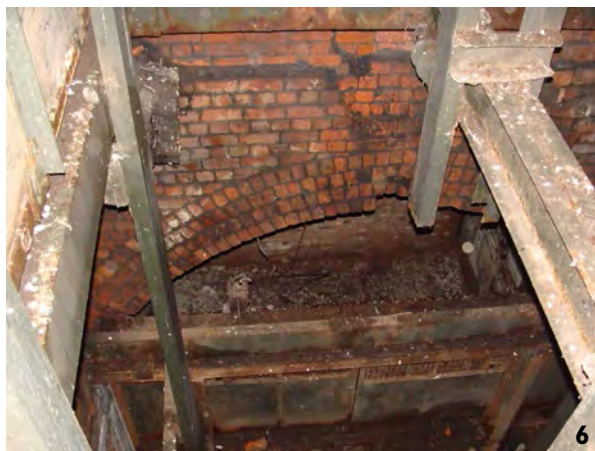
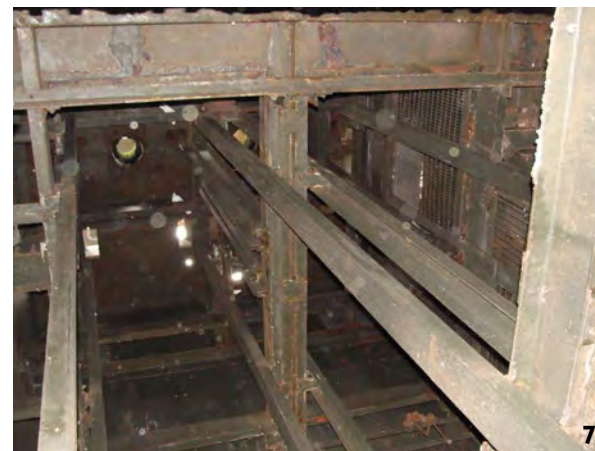
The headstock building is smaller and of a similar construction to the winding house; built in brick of various dates, surmounted by the steel headstocks and lift structure. The brick structure is buttressed and forms part of the structural support for the headstocks above. Internally the shaft retains its cages, gates and other control and maintenance equipment.

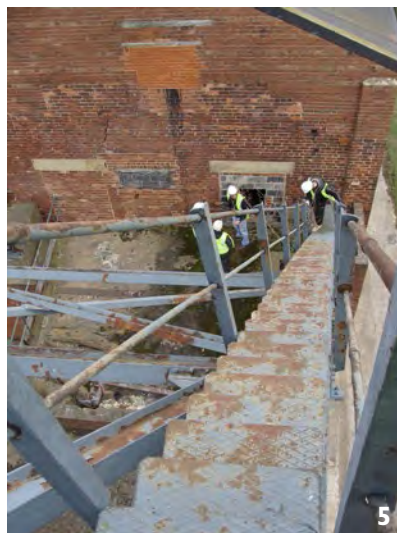
There is vegetation growth around the building, in particular to the base of the structure, the face of the brickwork and larger vegetation growth on the roof of the shaft head building. The steelwork has corroded in various places and is contributing to the erosion of the brickwork. There are areas of walls that have been damaged due to water ingress. There are various patch repairs to the brickwork in places. The south elevation of the engine house appears to be bowed and warped. There are various cracks to the buildings and the brickwork is damaged in places, particularly to the corners of the buildings. The roof appears to be intact, however there is evidence of moss and vegetation growth in the gutters and downpipes are missing. The base of the structure appears stable and there is a concrete base around the whole of the structure with no evidence of damage or vegetation growth.⁴

- 1 Corroded steelwork internally (© BMBC)
- 2 Corroded steelwork to the floor internally (© BMBC)
- 3 Winding engine house roof (© BMBC)
- 4 Corrosion of the steel headstocks (© BMBC)
- 5 View down the headstock gantry towards the winding house gable (© BMBC)

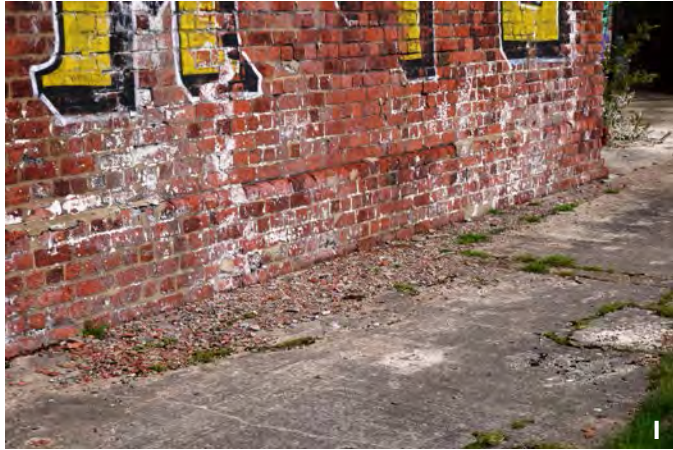
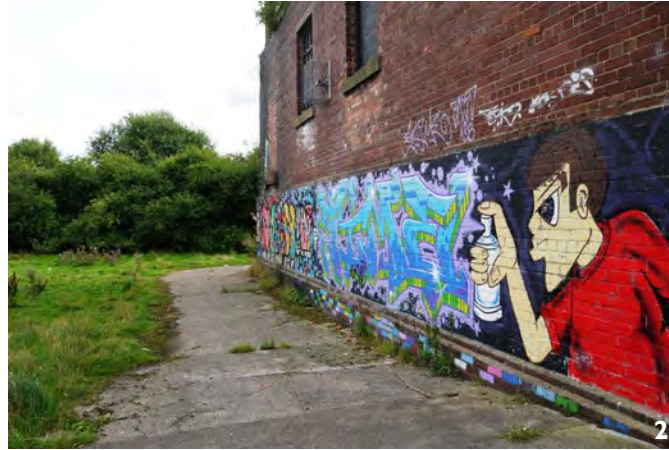
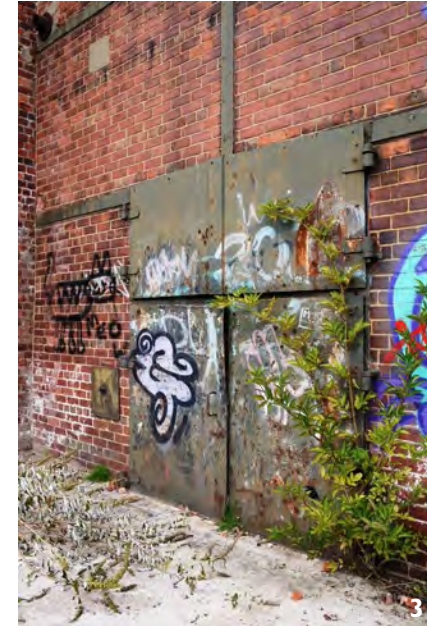
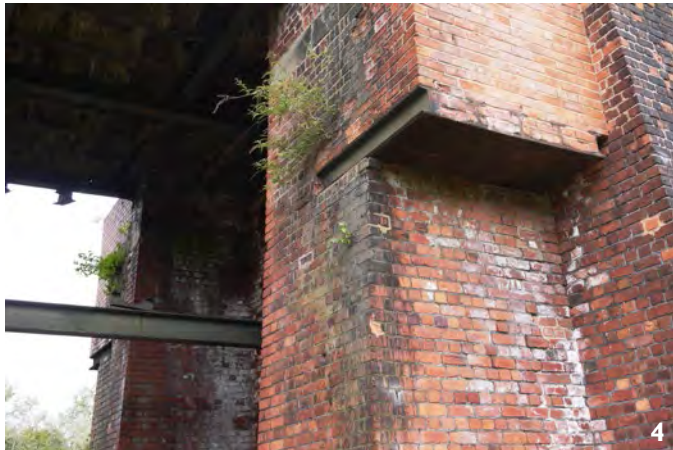
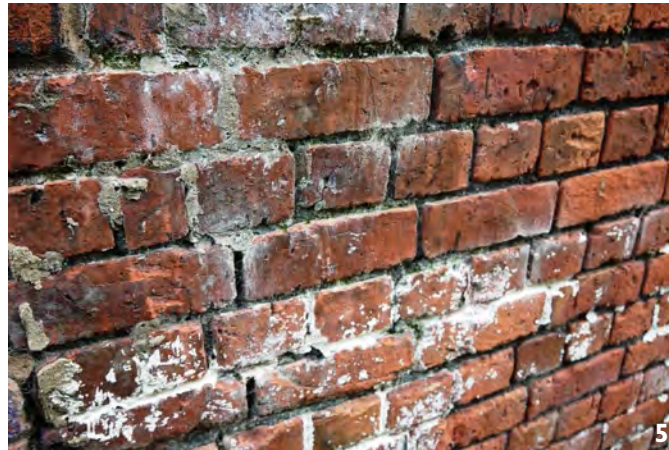
- 1 Spalling of the early 20th century brickwork
- 2 Graffiti on the north-east side of the winding house
- 3 Blocked entrances to the building
- 4 Plant growth at high level
- 5 Brickwork in need of repointing

Defects: The annotated elevations on the pages 23 and 26 identify our observations regarding the defects currently present within the building fabric. These findings would form a basis upon which a full condition survey and recommendations could be produced in due course.

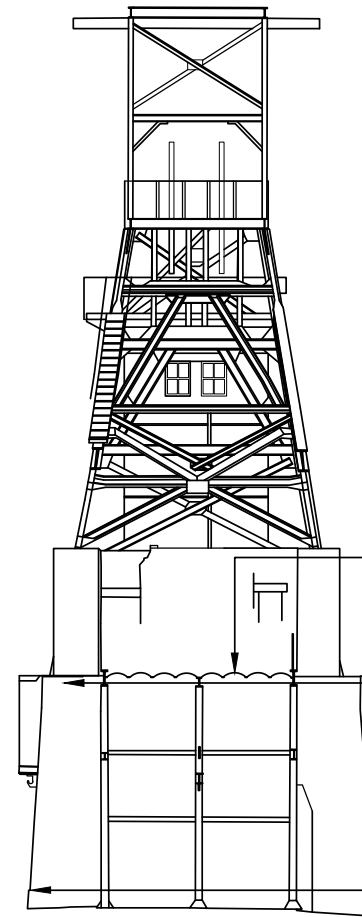
Inner East Elevation

Spalling to underside of vaults could be due to expansion of saturated metalwork. Review and consolidation advisable

Upper course of brickwork is missing and courses below are showing signs of eroding

Corner of plinth has deteriorated and may be allowing water ingress

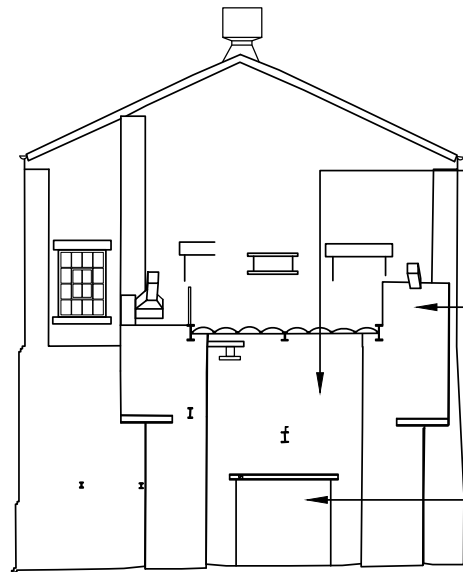
Inner West Elevation

Previous repair to crack is evident and may require further investigation

Eroded brickwork is likely due to cementitious mortar repointing. Consider raking out and repointing in lime mortar. Isolated brickwork replacement may be required.

Bricked/blocked up openings throughout are not toothed in and could be reopened with minimal damage to surrounding fabric

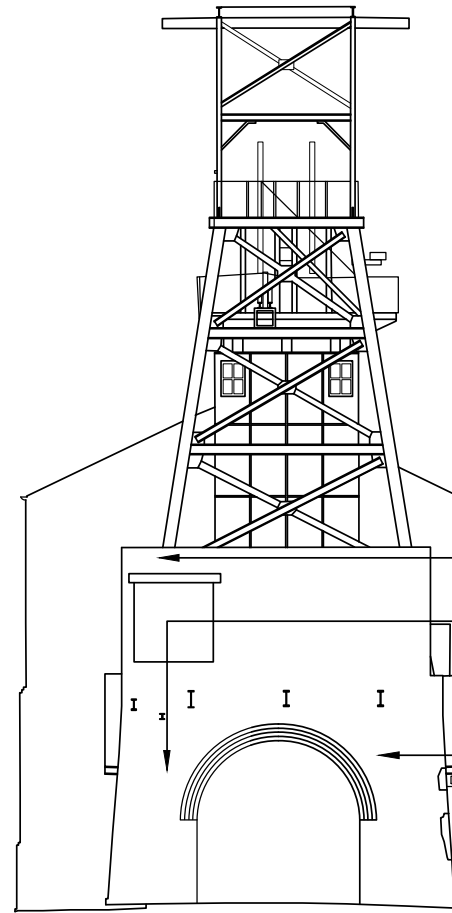
Crack visible at high level

Render patch may be protecting eroded brickwork behind. Further investigation is recommended

The lower section of this elevation is in poor condition compared to the remainder of the building with eroded brickwork and patch mortar repairs. Consider consolidating this elevation and repointing in lime mortar

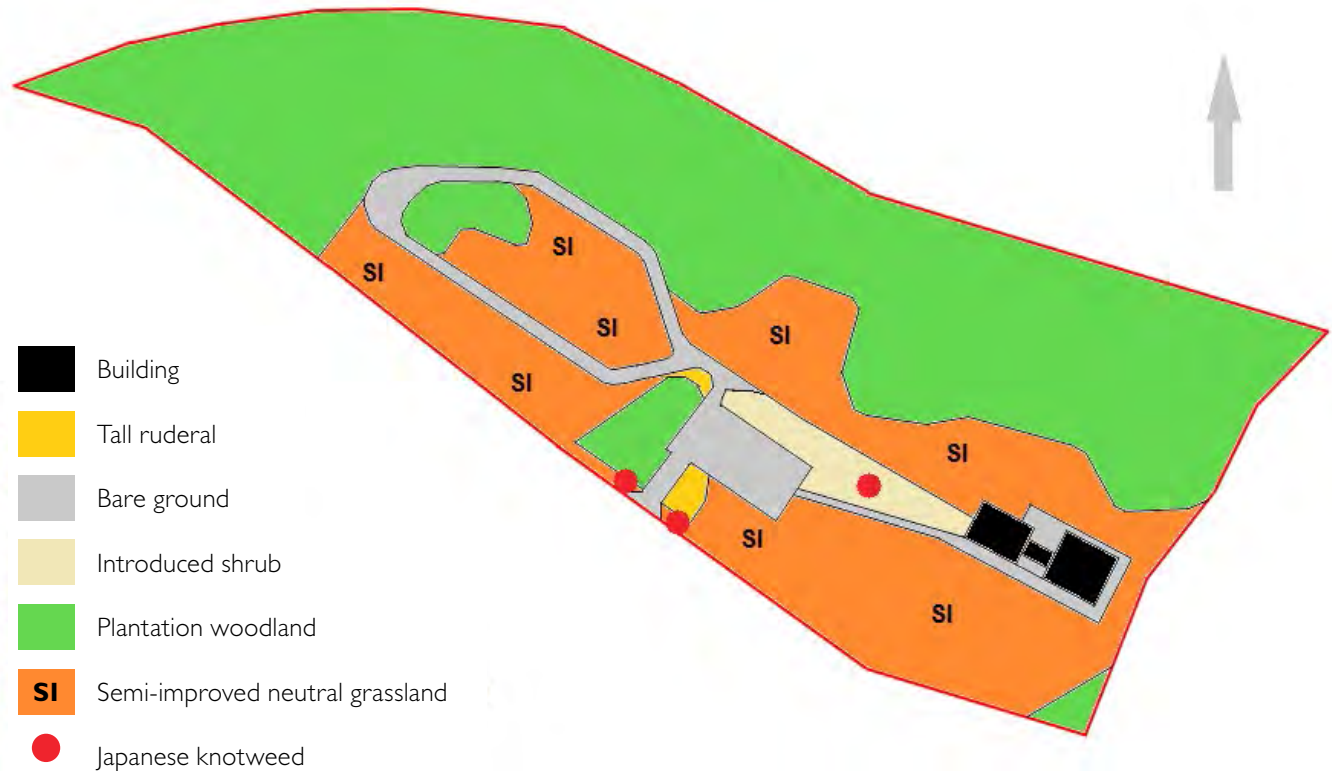
Schematic plan showing the various habitats on the site © Barrett Environmental, 2015

Tall ruderal: Several areas of dense bramble with nettle can be found on the site. A dense stand of Japanese Knotweed should be noted.

Buildings: Door and window apertures have been sealed to prevent unauthorised access, but small gaps in the walls provide potential access for bats and birds to the interior, and in the absence of full surveys, occupation by roosting bats and breeding birds is presumed.

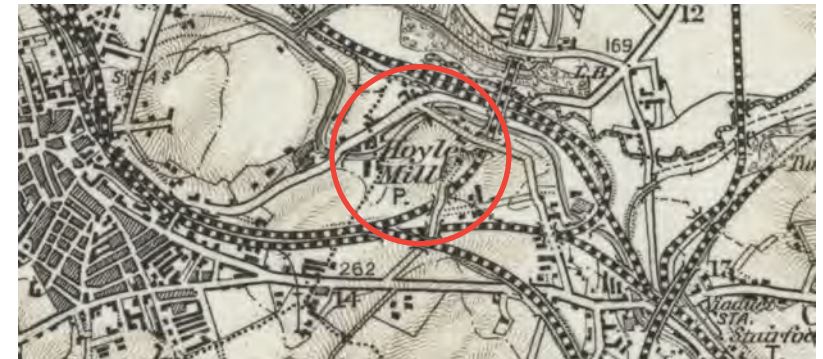
1896 OS map

By the time of the 1892 and 1896 OS maps the colliery is shown to have grown substantially. The area formerly identified as the Hoyle Mill site has been renamed as Rylands Main Colliery. North of the site, the river has been straightened and the railway line extended. It was around this time that the workings at the southern end of the site has been extended to include a large number of buildings. The tram road linking the north and south workings had been removed and a branch of the railway extended through the middle.

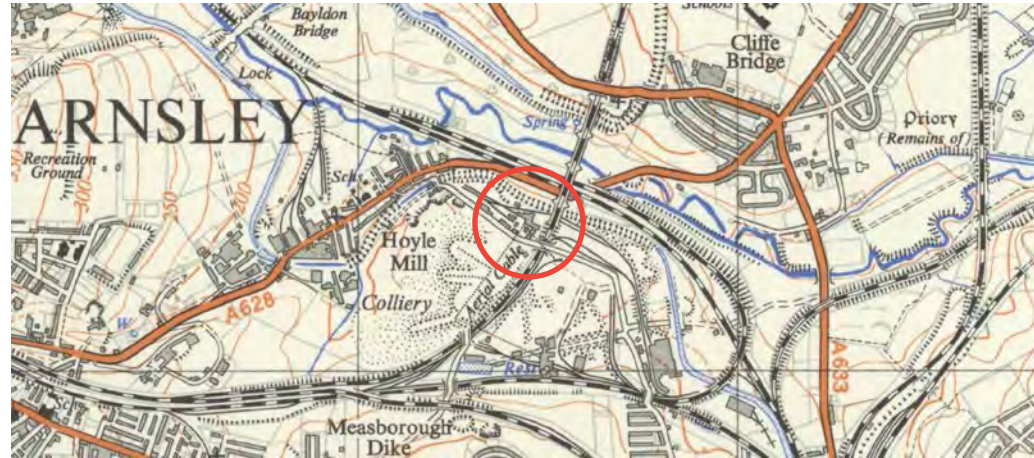
1955 OS map

An aerial photograph of the colliery taken in 1952 depicts the Barnsley Main Colliery at the south end of the site, shown here in the foreground. The smaller cluster of buildings visible in the background shows the area known as the Barrow Colliery and site of the surviving engine house. Large areas of the site are covered by immense spoil heaps; these have been levelled out in recent years. By the time of the 1955 Ordnance Survey Map, the buildings constructed in 1938 had been dismantled. The buildings in the northern end of the site remained largely unchanged at this time and the aerial cable system would appear to still be in operation.

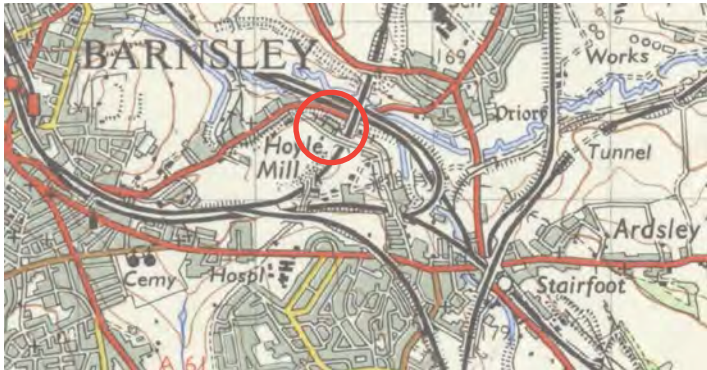
1961 OS map

The early 1960s saw a rapid dismantling of the colliery site, including the aerial ropeway by 1962. Though buildings remained at the northern end, many of the railway sidings were removed and several buildings to the south were demolished along with the aerial cable system. Much of the site appears to be covered by spoil heaps. Barnsley Main officially closed in 1967 and was mothballed (allowing it to be reopened at a later date), following an accelerated pit-closure programme, though the coal seams themselves were still worked from Barrow Colliery. By the 1970s the railway line to the north and through the centre of the site had been completely dismantled. The southern railway line had been partially dismantled though a section of it is still in use today.

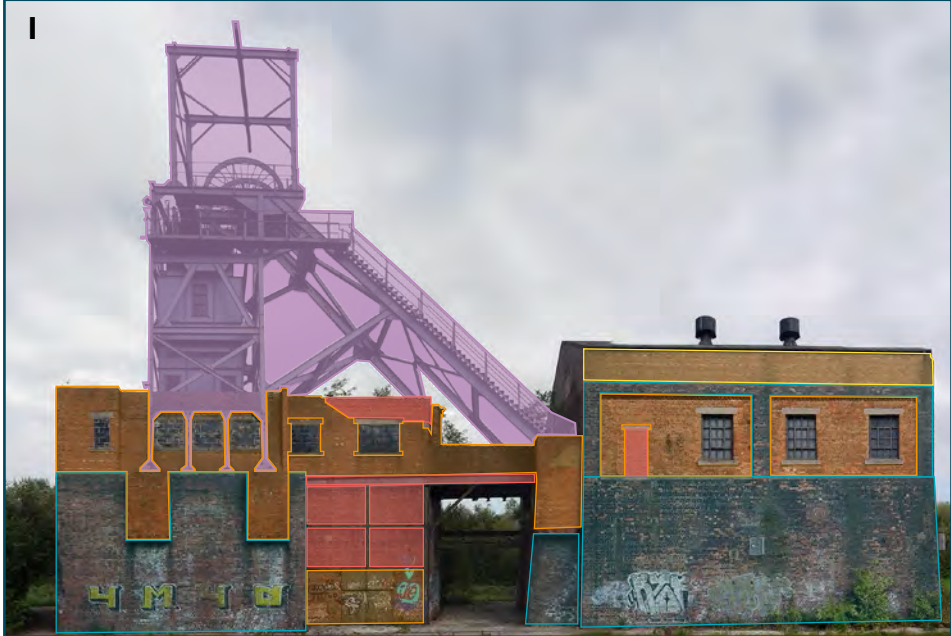
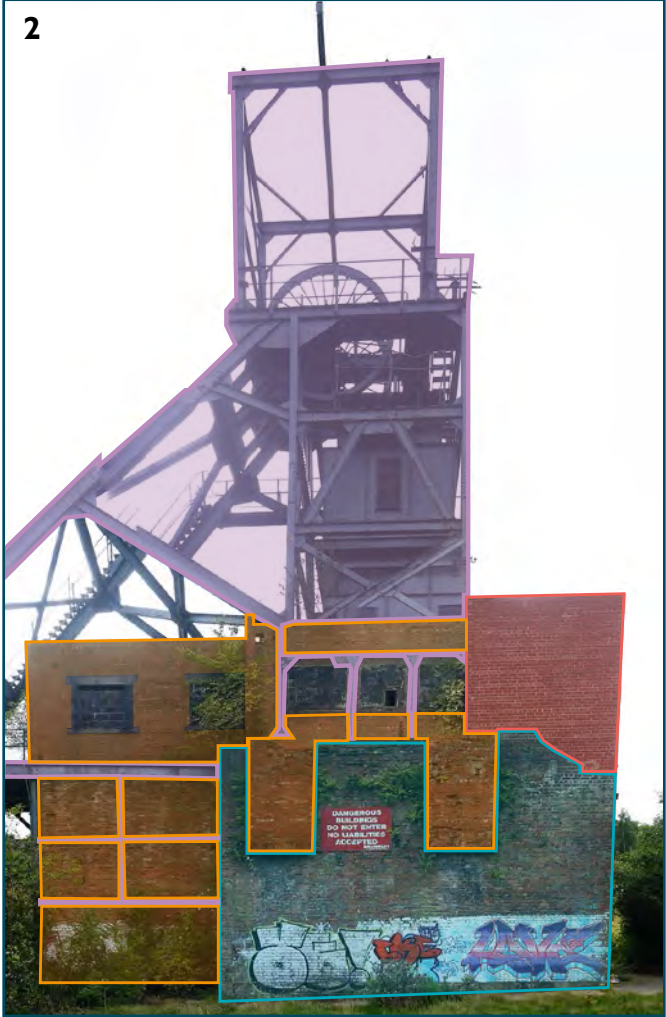
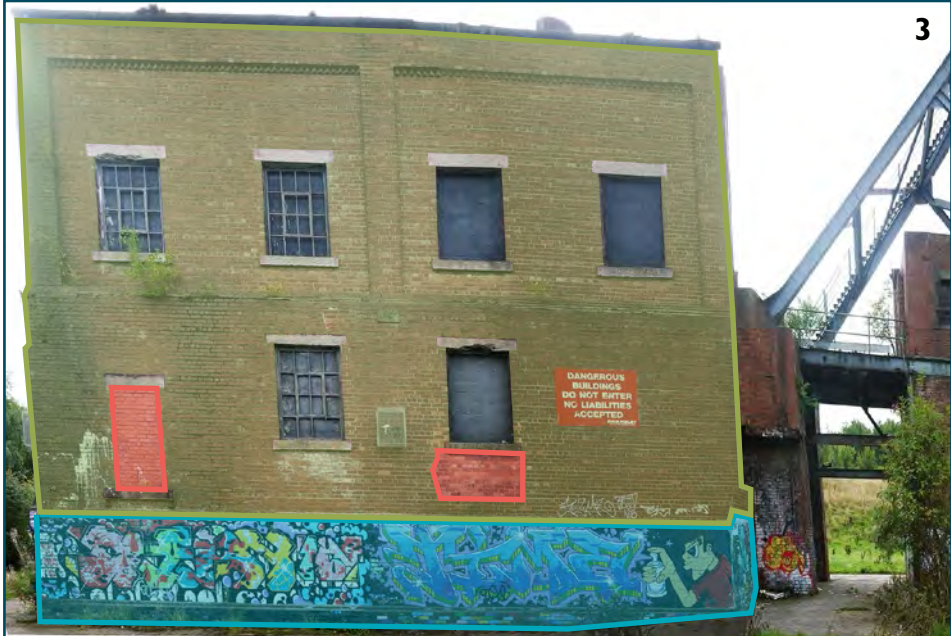
PHASES OF DEVELOPMENT ELEVATIONS

- Early 20th century
- 1940s
- Additions 1956
- Brickwork associated with raised room 1950s
- Late-20th century
- Headstock structure

South-east elevation: This elevation contains the oldest fabric in English Bond at ground floor level and English Garden Wall Bond at first floor level. The elevation contains a blocked window with stone lintel and cill and another with a round arched opening with stone cill. The blocked openings make use of Scottish Bond. The gable end brickwork is a replacement in Garden Wall Bond and three windows have been inserted with concrete cills, lintels and steel window frames. A large opening at ground floor level is a modern insertion.

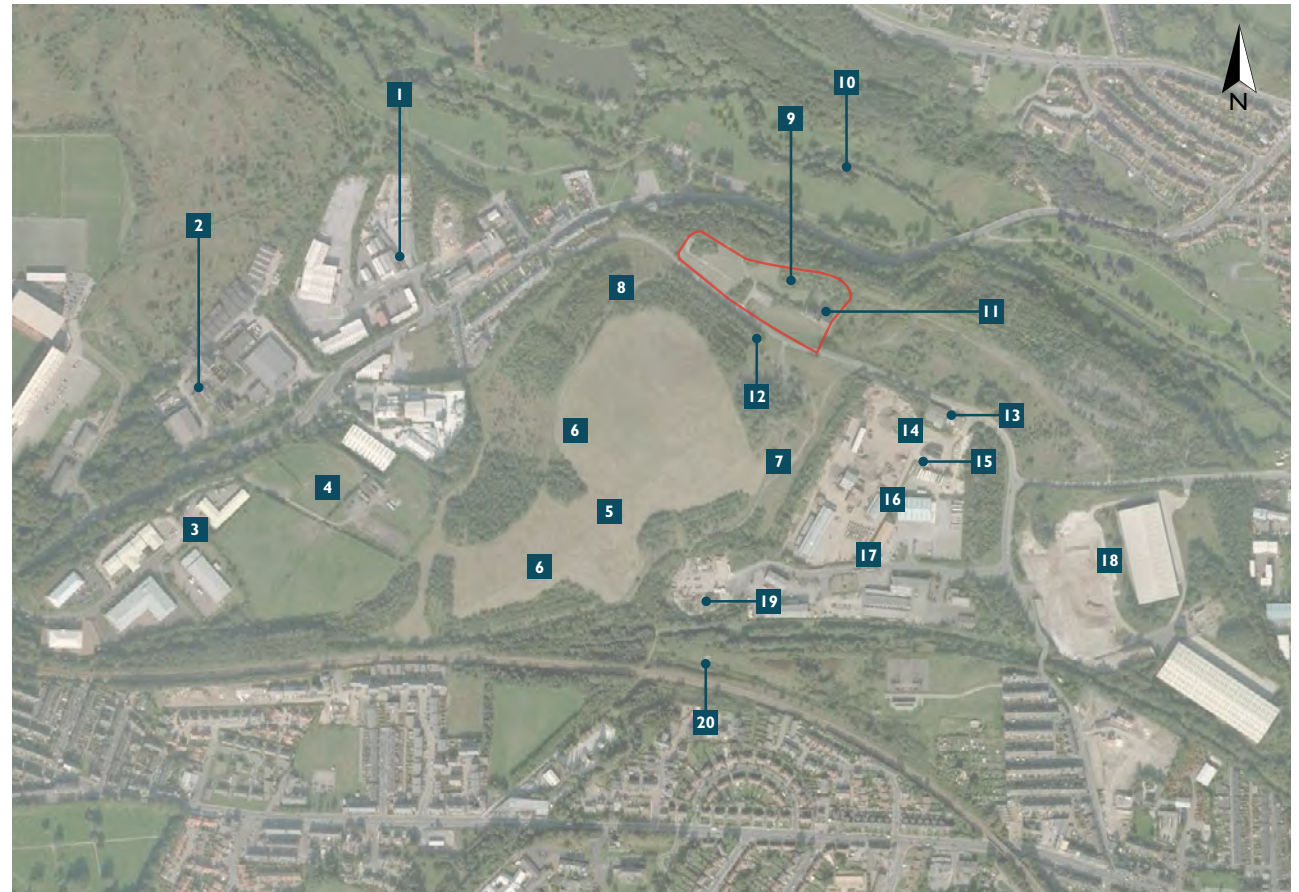
1	Site of former Hoyle Mill Bleach Works c.1855
2	Site of former Beevor Hall Bleach Works c.1855
3	Site of former Borough Flint Glass Works c.1892
4	Site of Oaks Glass Bottle Works c.1892
5	Location of a large sandstone quarry in 1855
6	Levelled spoil heaps
7	Former railway line/tram road
8	Site of Hoyle Mill Sandstone Quarry c.1855 (shown as disused in 1892)
9	Railway sidings removed c.1965
10	This section of river was straightened c.1892-96
11	Originally known as the 'Hoyle Mill side' of the Oaks Colliery in 1855, this became known as Rylands Main Colliery in 1892 and later Barnsley Main Colliery (along with the rest of the site) in 1906. After the reopening of the site in the 1970s this part of the site was known as the Barrow Colliery (the company had merged with another mine owner to form the Barrow Barnsley Colliery Co.)
12	Former site of Cupola House
13	Ancillary site buildings
14	Site of early 20th century Coke Ovens

15	General offices
16	Site of 1970s Depot and Works buildings
17	Site of old coke ovens c.1892 to c.early 20th century
18	Site of former Hope Glass Works c.1892 to c.1950s
19	Original site of the Oaks Quarry and site of the 1886 disaster. The site was taken over by the Barnsley Main Colliery Co. in 1896, though it was referred to as 'Old Oaks Quarry' on the 1906 OS map. Referred to as the Barnsley Main Colliery on later maps.
20	Site of Landing Place and Weigh House of Oaks Colliery c.1855

1855 OS map with the location of the existing engine house and pithead indicated in red markup as shown below.
Baseplan © 2015 Infoterra Ltd & Bluesky

The site is depicted on the second edition 1855 Ordnance Survey map. By this time the colliery had expanded to include a coal winding shaft and pumping shaft south of the canal. Known as the Hoyle Mill side, these shafts were supplemented by several coke ovens. The original workings to the south, marked on the OS map as the Landing Place and Weigh House, abut the Yorkshire railway line. The north and south sites were linked by a tram road, to the east of which was located a sandstone quarry identified as Oaks Quarry.

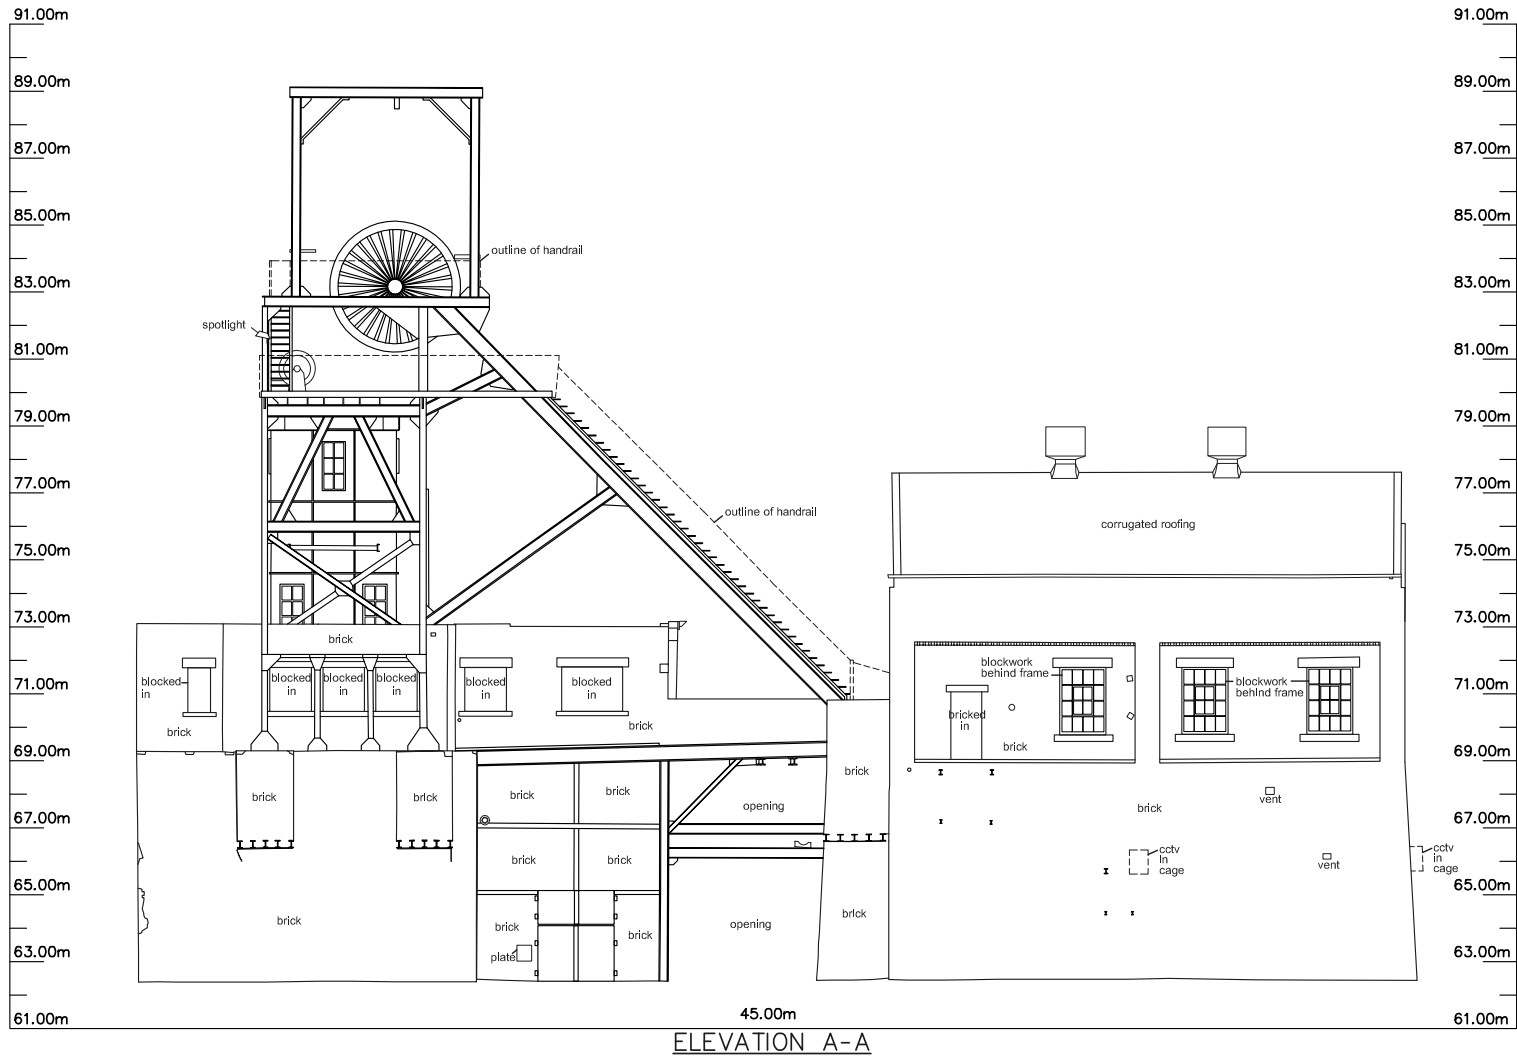
A-A – south-west elevation – winding house and headstocks building

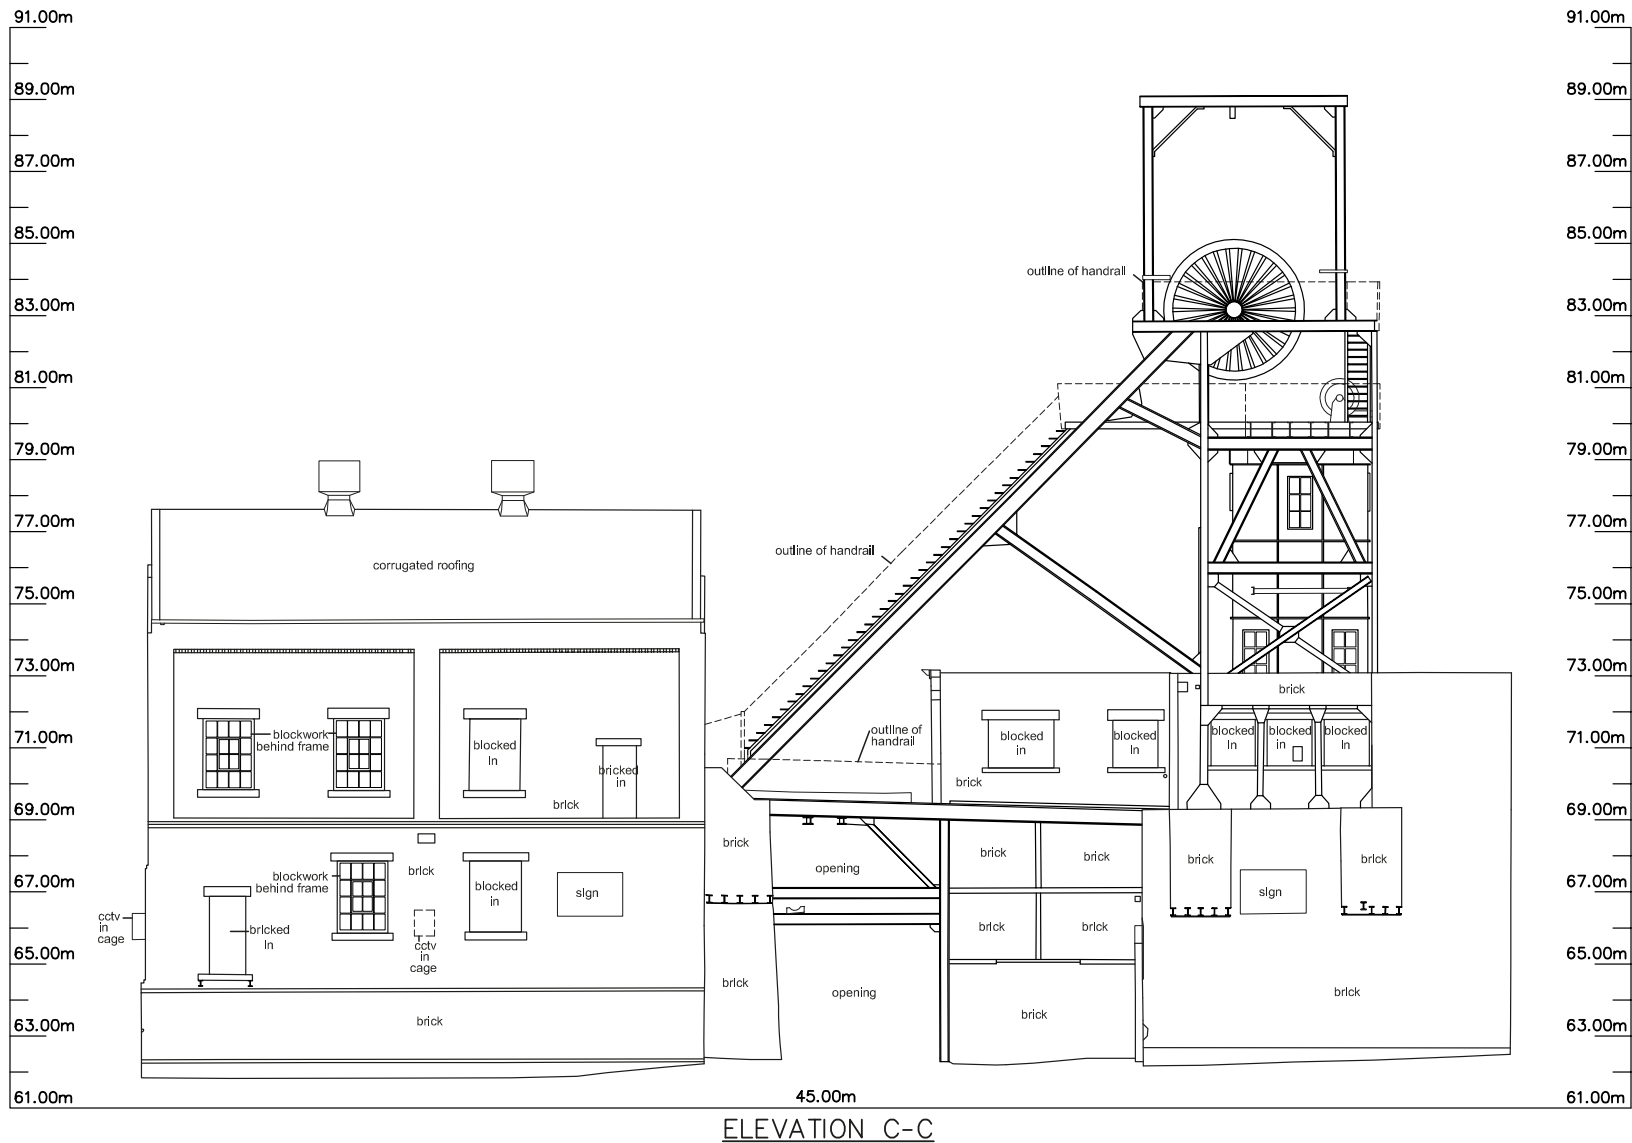
C-C – north-east elevation – winding house and headstocks building

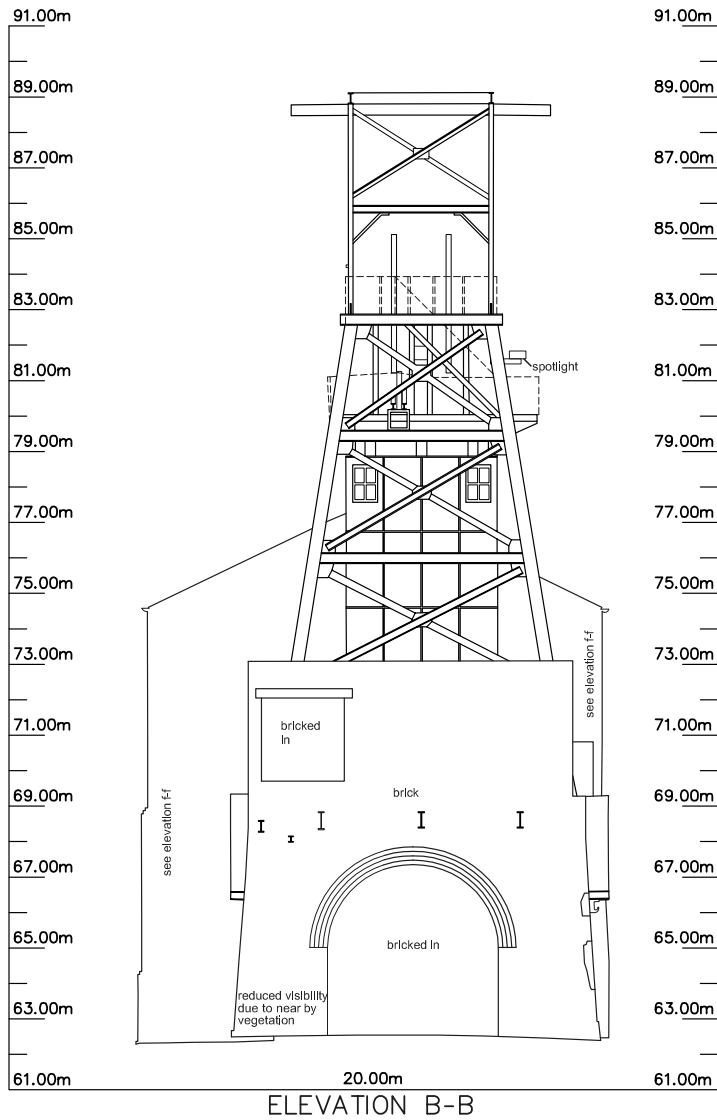
B-B – north-west elevation – headstocks building

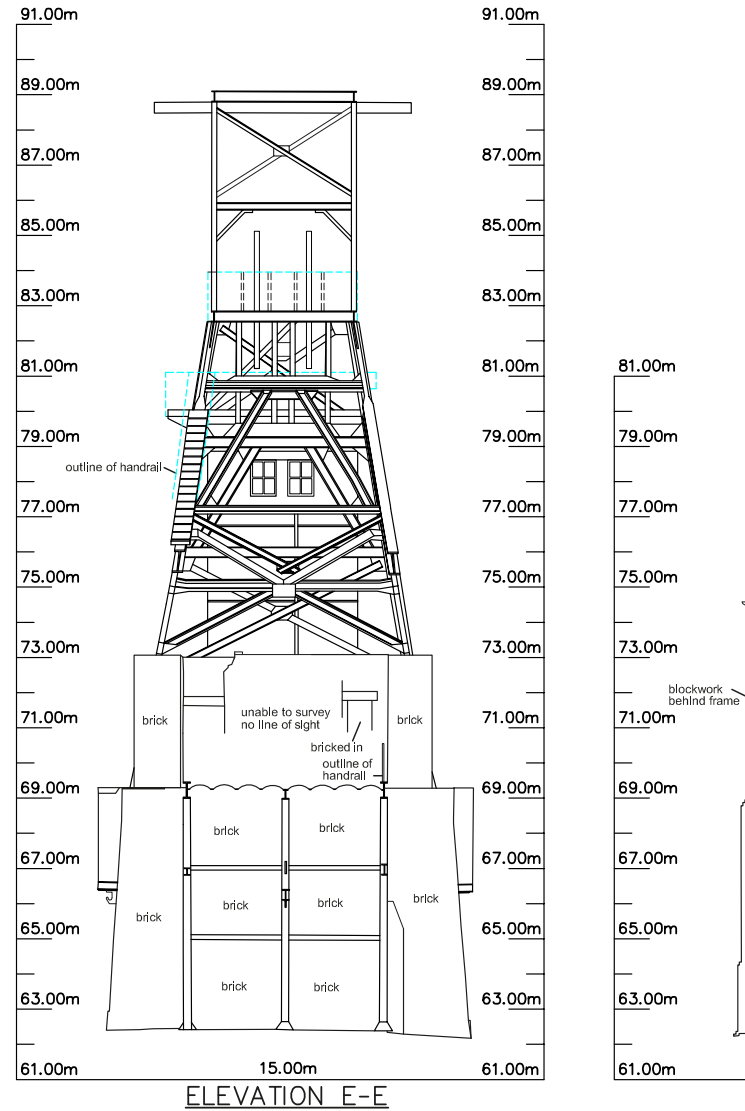
E-E - south-east elevation – headstocks building
